CORNER RECORD

Document Number CR 8967

City of EDEN TOWNSHIP County of ALAMEDA, California

Brief Legal Description IRON PIPE MONUMENT LOCATED WITHIN N. 5TH STREET

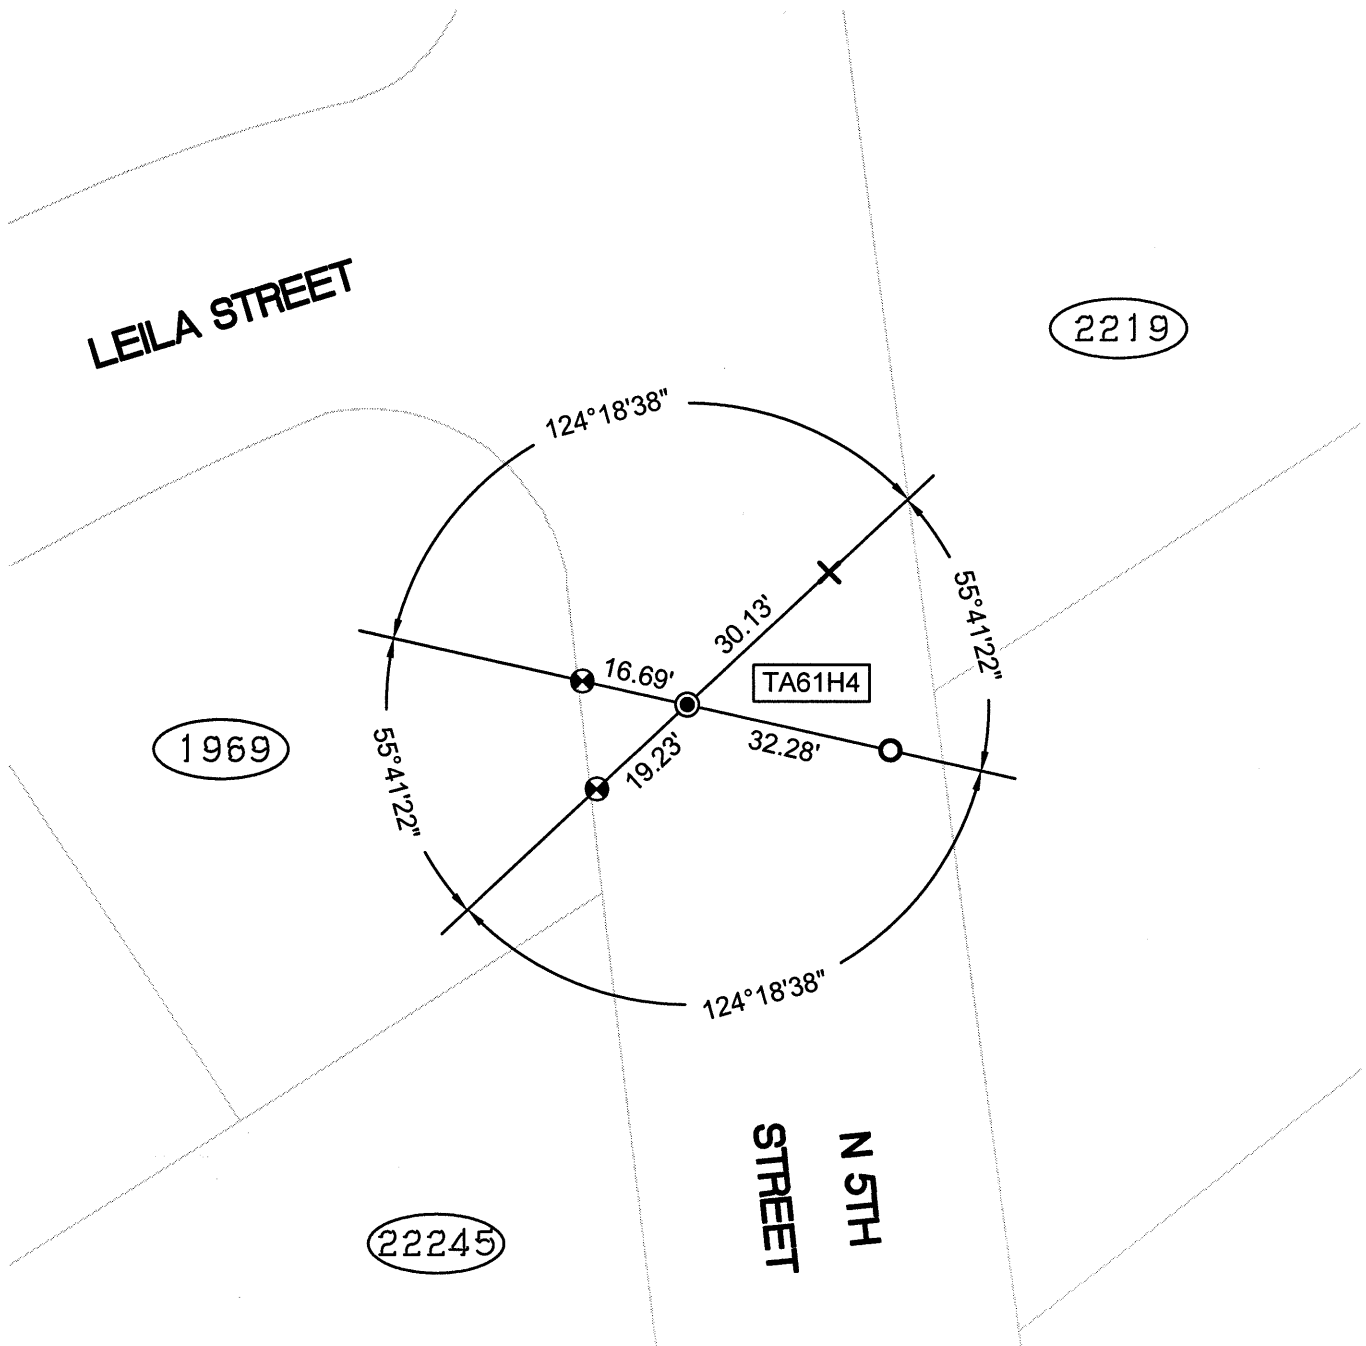
Identification and type of corner found: Evidence used to identify or procedure used to establish or reestablish the corner:
FOUND DEGRADED IRON PIPE WITH NAIL IN MONUMENT WELL.

THIS POINT WAS REFERENCED PRIOR TO A CONSTRUCTION PROJECT IN THE VICINITY.

A description of the physical condition of the monument as found and as set or reset: _____
FOUND AND SET POINTS AS SHOWN ON PAGE 2.

THE TIES SHOWN HEREON ARE FOR THE PURPOSE OF PERPETUATING FOUND MONUMENTATION.
